Manhole Inspection Summary

Manhole # S21CC1005MH

Insp Date: **3/13/07 1:42 PM**

Location Address: **2006 DRUID PARK DR**

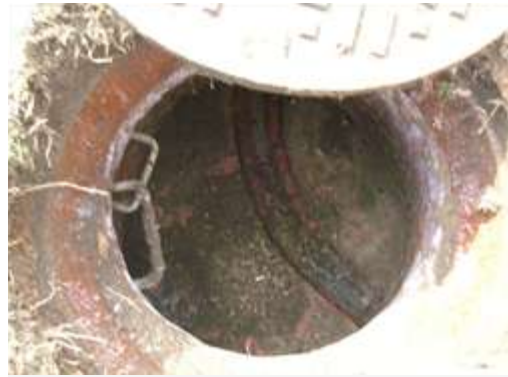
Top View

Evidence of surcharge - Bench debris.
Channel debris.

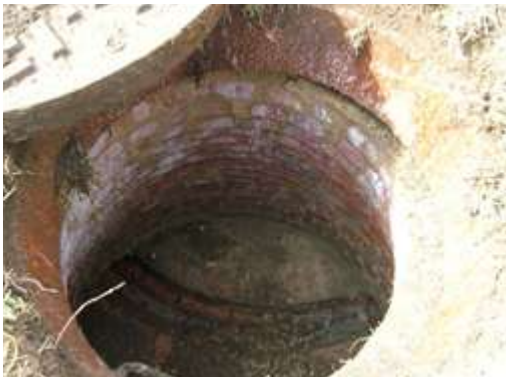
Defect

Frame leaks. Frame offset. Adjustment deterioration and infiltration. Corbel and Barrel infiltration - other side.

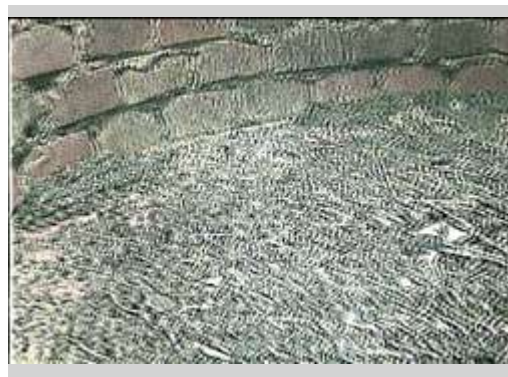
Defect

Barrel deterioration and infiltration. Bench debris.

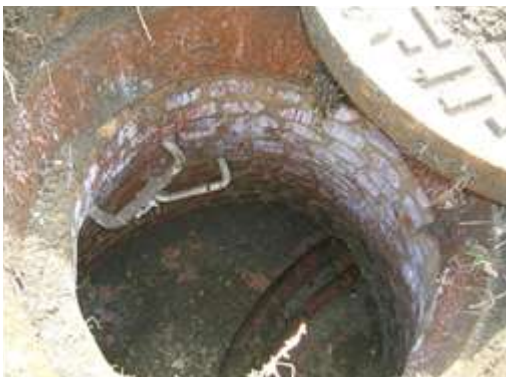
Defect

Frame leaks. Frame offset. Adjustment deterioration and infiltration. Corbel and Barrel infiltration

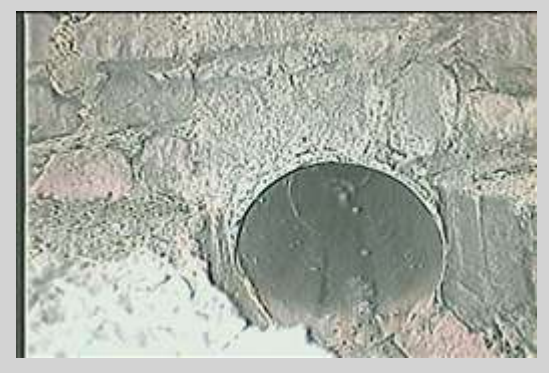
8 in. Circular Gravity Sewer Pipe Out @ 12 O'Clock

Infiltration: **None** Pipe Seal Cond: **Cracked**

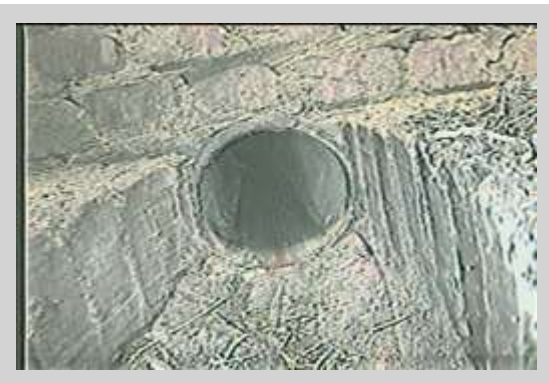
6 in. Circular Gravity Sewer Pipe In @ 5 O'Clock

Barrel deterioration and infiltration. Channel deterioration.

Deposits: ☐ None ☐ Mud ☐ Sludge ☐ Debris ☒ Grease

Infiltration: **Evidence** Pipe Seal Cond: **Unknown**
